HP Indigo ElectroInk Filling Stage Improvement Program

Edna Dezanashvili
October 2020

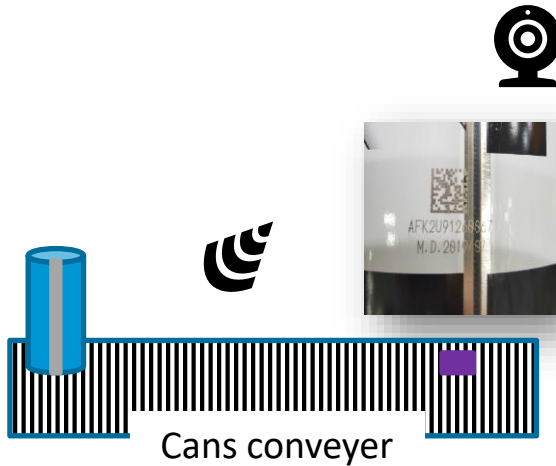
Before

Barcode Burn on Silver Line - Ser.3 barcode burn on silver line decreased by camera angle range enlargement

Camera didn't detect the can Silver line, leading to barcode burn on it, which impact barcode scanning

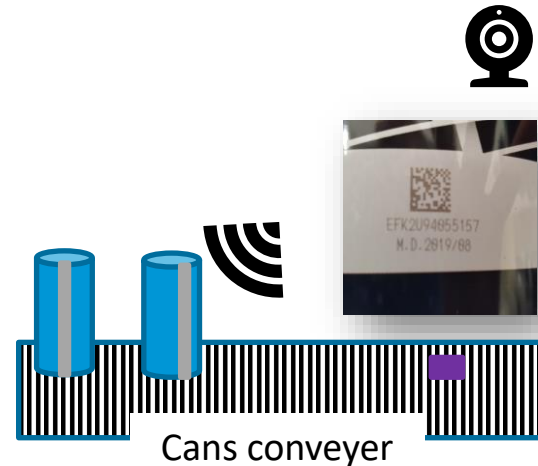
After

Camera angle range enlargement improved can Silver line detection, which enables can rotation and eliminating barcode burn on Silver line

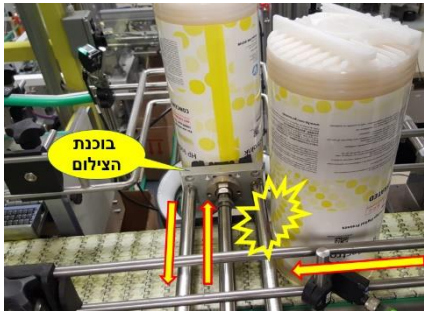
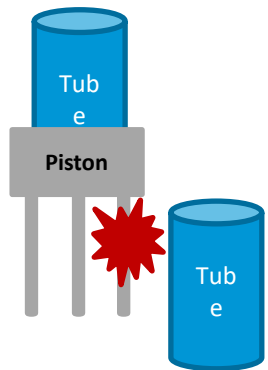
Before

Tube Break - tube break due to vision piston decreased by mechanical gates

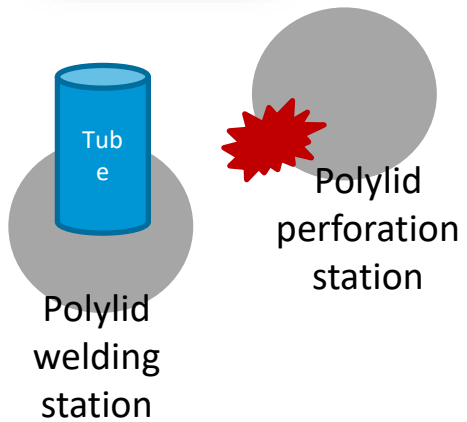
Before

Polylid Delamination - occur at end of filling stage, 2 last tubes. Welding area wasn't cure, thus, polylid peeled once the tube moved to next station. Decreased by setting curing time of 3 seconds at end stage

Polylid delamination

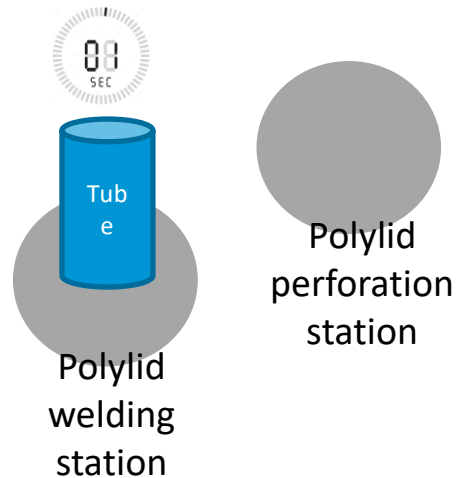
After

No polylid delamination

* Solution cost - None
