HP Indigo ElectroInk Filling Stage Improvement Program

Edna Dezanashvili
October 2020

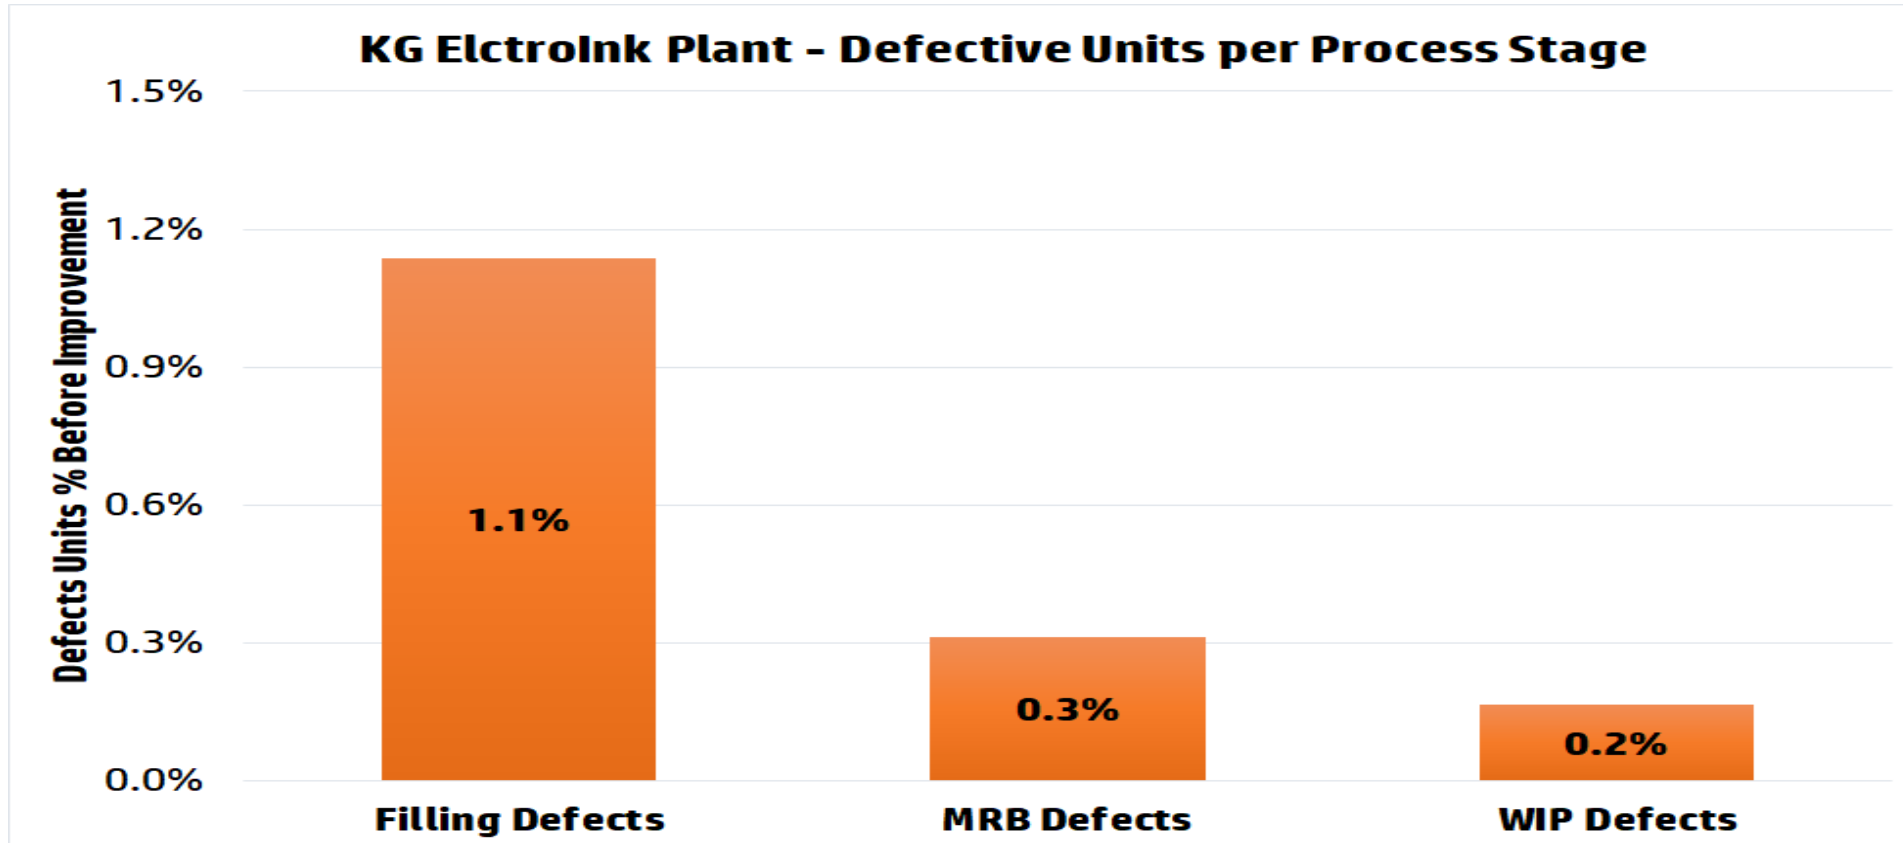
Defective units which lead to scrap, detected mainly at **filling** stage,.
1.1% from overall production resulting in scrap and inconsistent work.

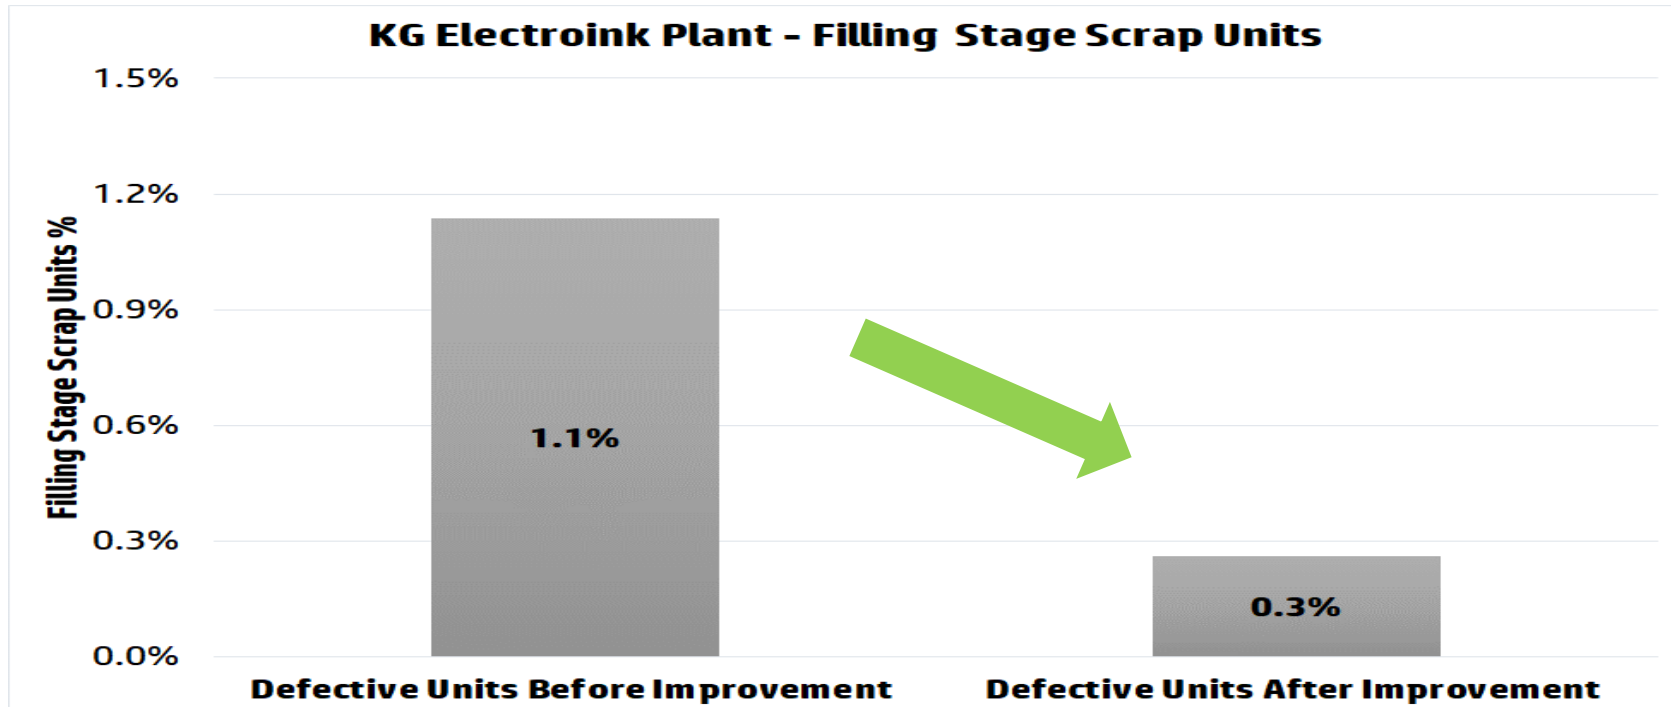
Filling issues which treated by team leading to defective and scrap units decrease:

- [Ser.3 barcode burn on silver line](#)
- [Tube break](#)
- [Polylid plunger delamination](#)

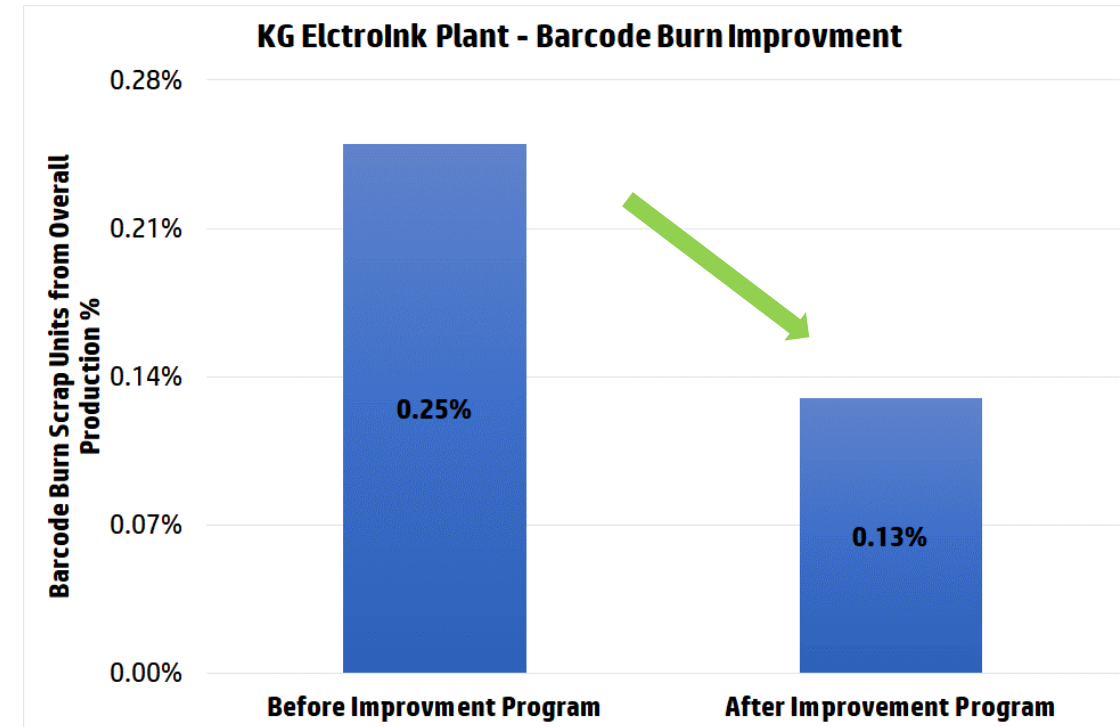
Ser.3 FM – Burn on Silver Line

Barcode Burn on Silver Line - Ser.3 barcode burn on silver line decreased by camera angle range enlargement

Camera didn't detect the can Silver line, leading to barcode burn on it, which impact barcode scanning

Camera angle range enlargement improved can Silver line detection, which enables can rotation and eliminating barcode burn on Silver line

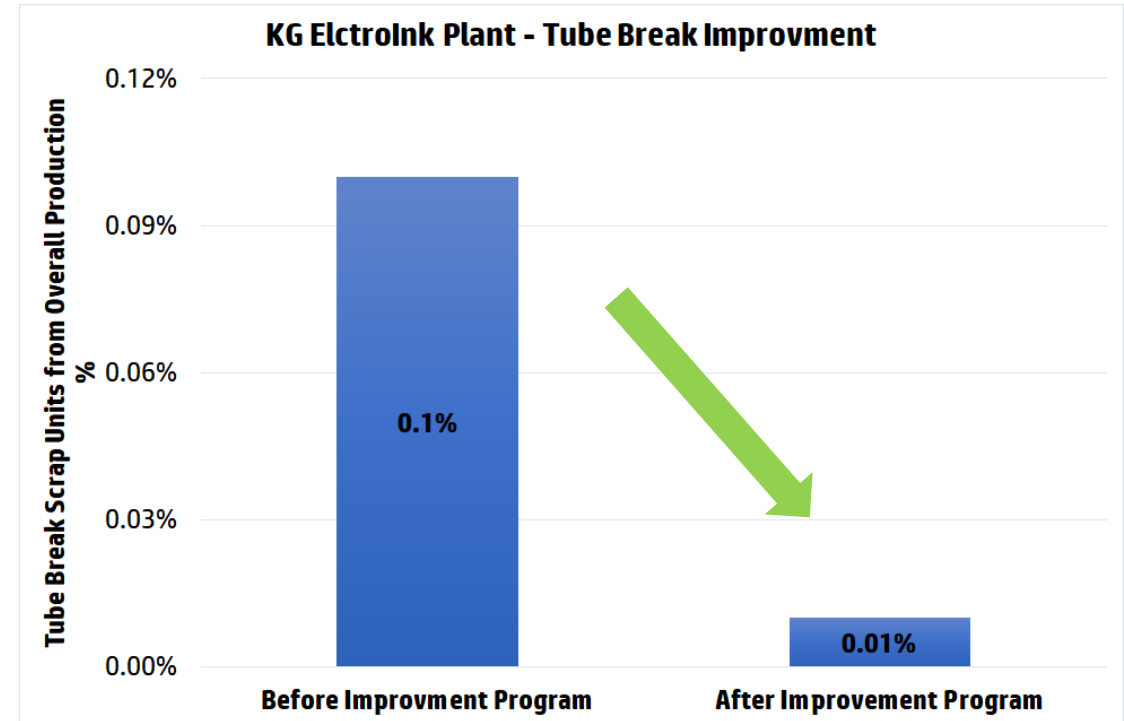
Ser.4 HNVS FM – Tube Break

Tube Break - tube break due to vision piston decreased by mechanical gates

* Solution cost (one-time investment) - \$2K

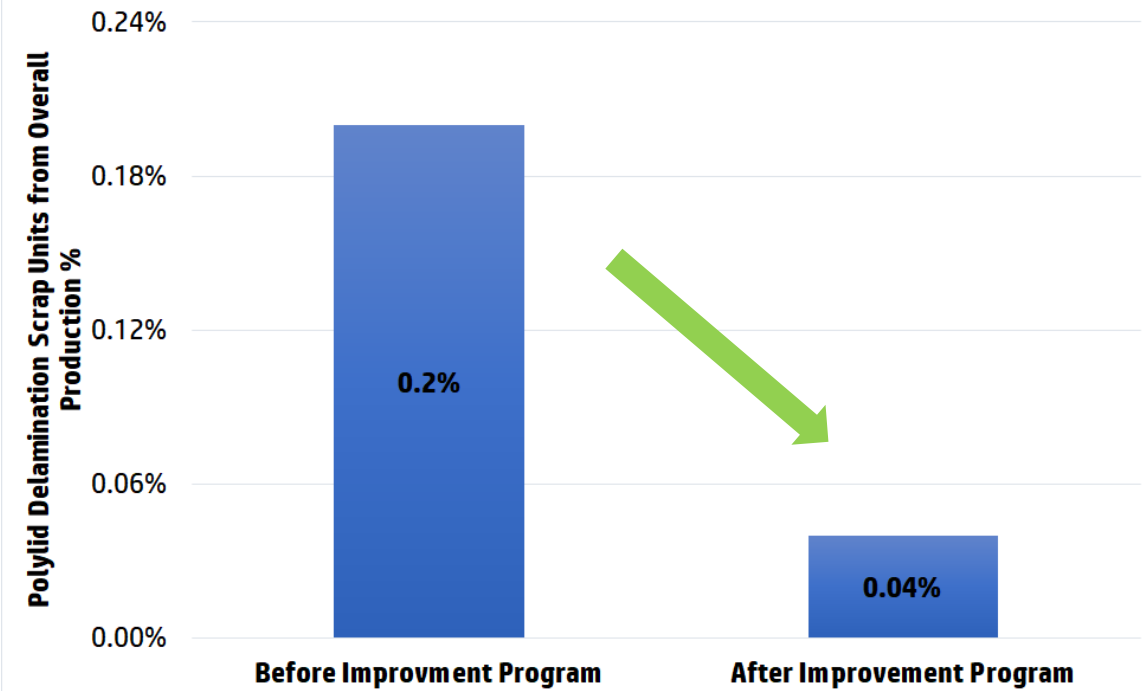
KG Ectrolnk Plant - Polylid Delamination Improvement

Polylid Delamination - occur at end of filling stage, 2 last tubes. Welding area wasn't cure, thus, polylid peeled once the tube moved to next station. Decreased by setting curing time of 3 seconds at end stage
